RE: 529 Washington St, Gary, Indiana

**Background:**

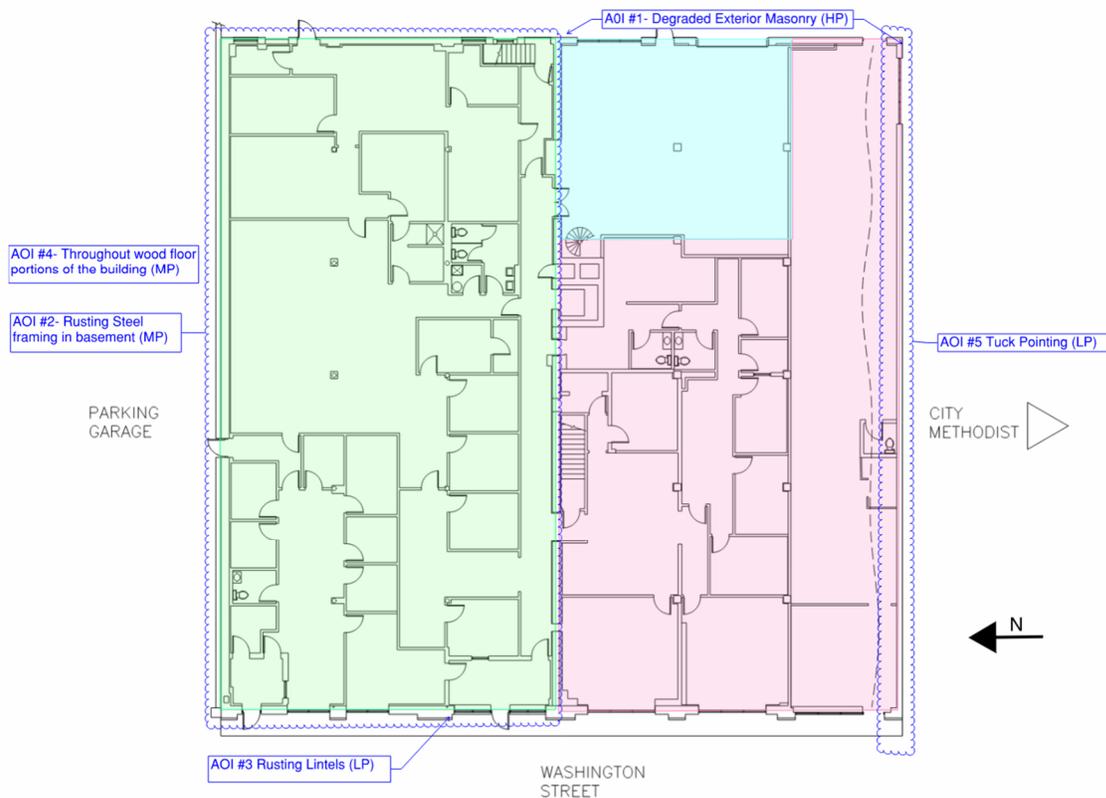
Figure 1 Location of Areas of Investigation (AOI)

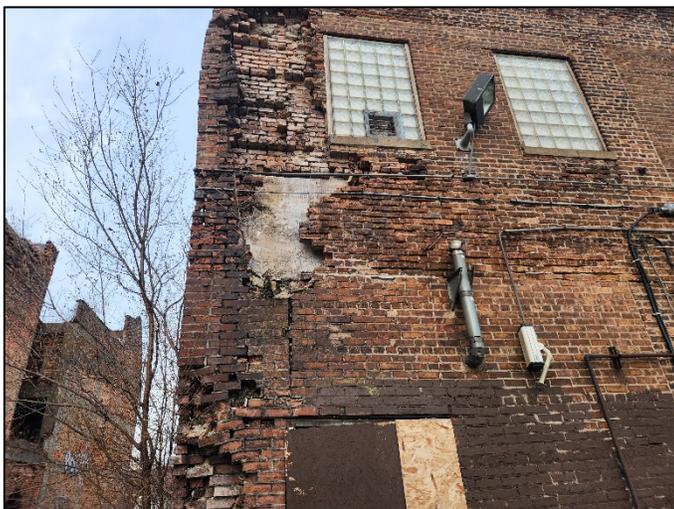
The southeast corner and a smaller middle portion of the building has significantly degraded as shown in figures 2-5. Two of three wythes or brick are gone and portions have light penetrating the interior as shown in figure 4. These wall sections can be repaired by shoring the adjacent floors from the ground to the roof before demolishing and rebuilding the damaged portion of masonry wall.

Figure 2: Southeast corner missing masonry – HP

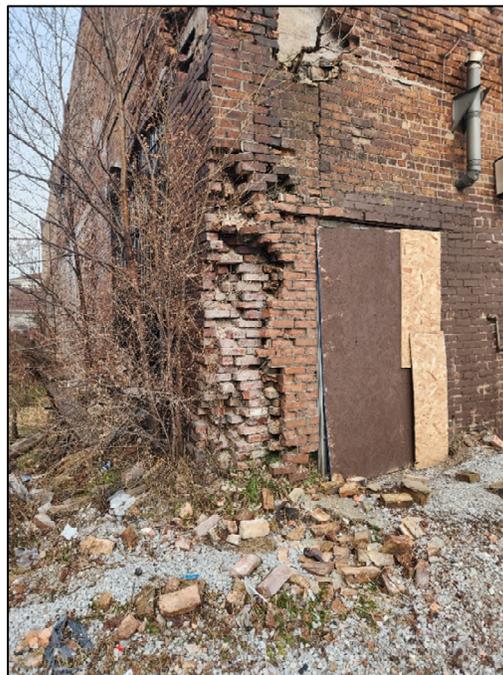
Figure 3: Southeast corner ground level - HP

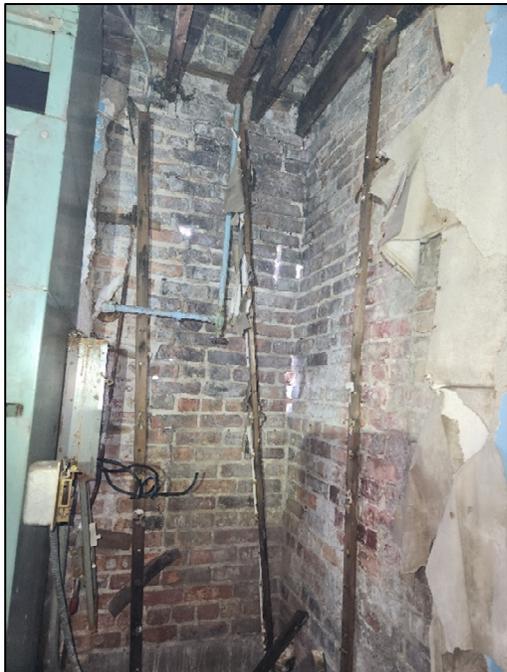
Figure 4: Southeast corner from 2<sup>nd</sup> floor inside – HP

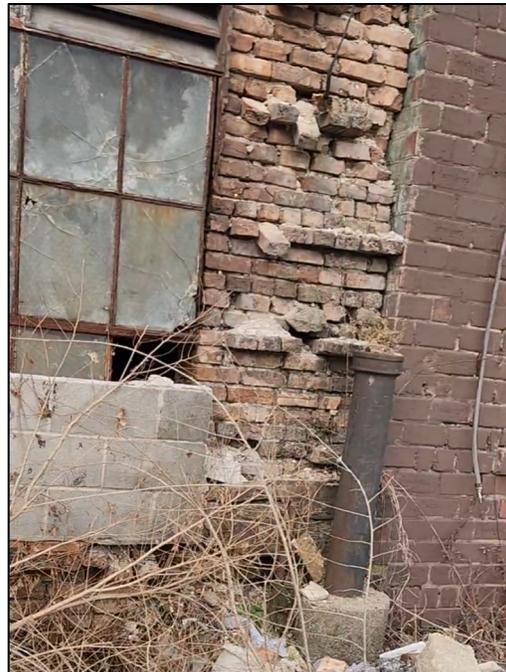
Figure 5: East wall hallway along building - HP

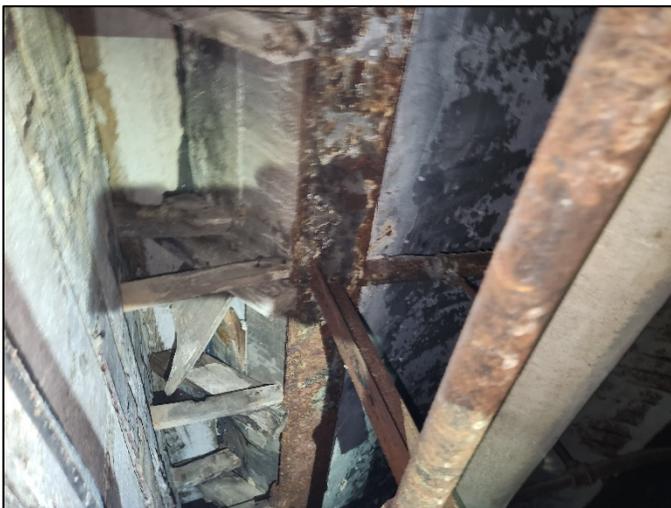
Steel floor beams throughout the basement are rusting as shown in figures 6-9. A more detailed evaluation should be conducted during the renovation. Sections with steel loss greater than 1/16<sup>th</sup> of an inch as measured by a caliper should be further evaluated by a structural engineer for potential repairs. Sections with loss less than 1/16<sup>th</sup> of an inch should have rust removed and be repainted. This entails sand blasting exposed portions to SSPC-SP6 and then repainting with two coats of a ZRC cold galvanizing compound to a minimum thickness of 3 mils. Select portions of the beam should be uncovered to confirm that there is not significant section loss in concealed portions of the beams.

Figure 6: Basement steel beam # 1 - MP

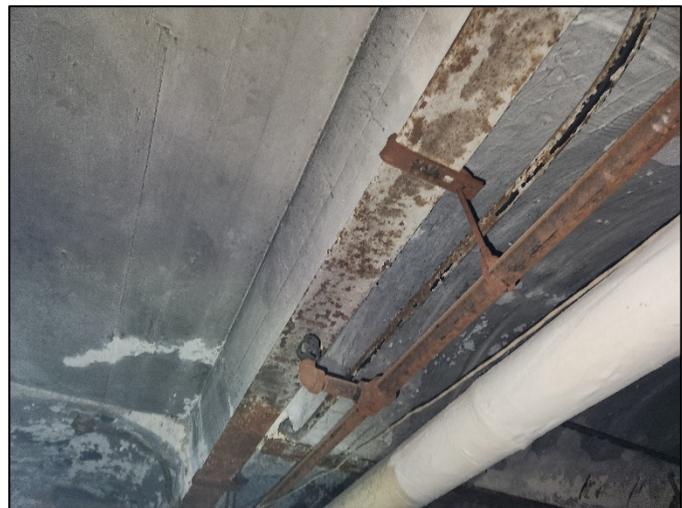
Figure 7: Basement steel beam # 2 - MP

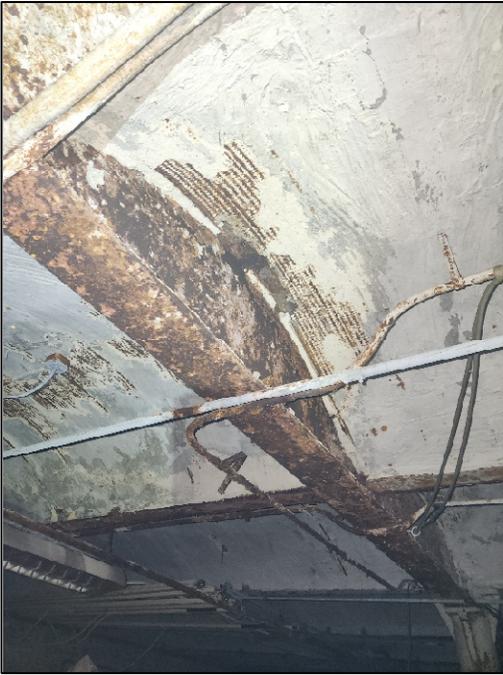
Figure 8: Basement steel beam # 3 - MP

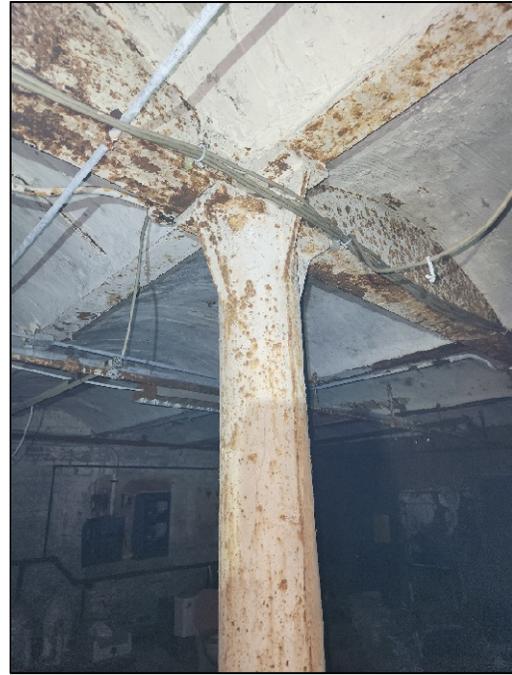
Figure 9: Basement steel column - MP

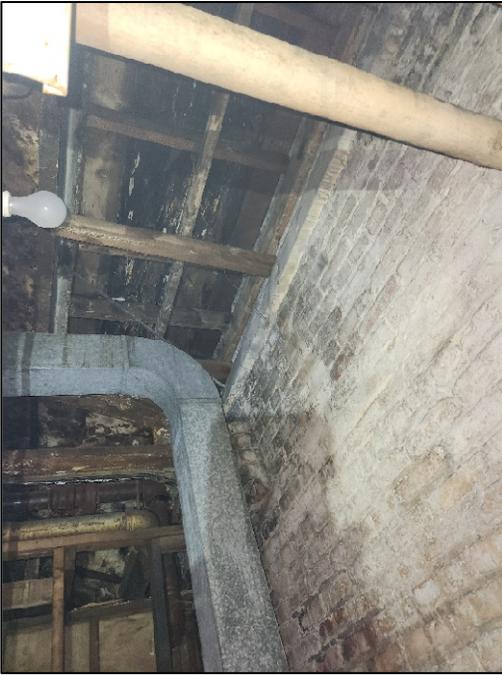
Localized portions of the wood decking are rotted as shown in figure 10. The rot appeared to be localized and not due to active leaks. Any rotted flooring sheathing, roof sheathing and rotted structural members should be repaired by replacement during renovation.

Figure 10: Rotting Roof decking - MP

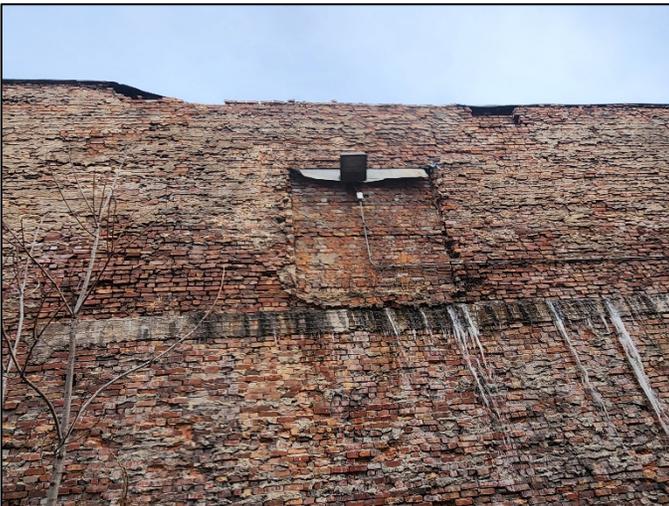
The south facing exterior masonry has several issues. First, there is a segment at the roof level that is missing flashing (shown in figure 11). This has potential for water intrusion and subsequent moisture damage. The roof of this segment should be evaluated for moisture damage during construction and roof flashing repaired. Fig 12 shows ice on the exterior and is likely due to pipe burst from the inside. Bricks in this area should be tested to see if they are soft and replaced if degraded. Secondly, much of the wall has much of its mortar missing as shown in figure 12. The entire face should be repointed with a type N mortar.

Figure 11: Ice and missing roof flashing - LP

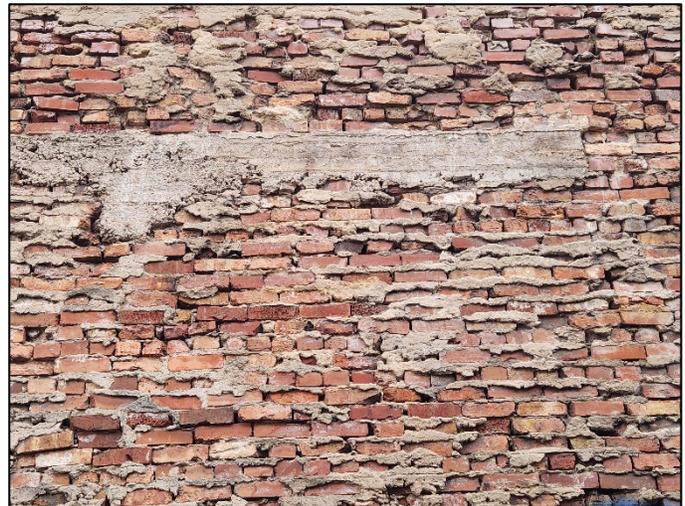
Figure 12: wall with missing mortar- LP
