# Stormwater Reduction and Water Budget for a Rain Garden on Sandy Soil, Gary, Indiana, 2016–18

Scientific Investigations Report 2022–5101

By David C. Lampe, E. Randall Bayless, and Danielle D. Follette

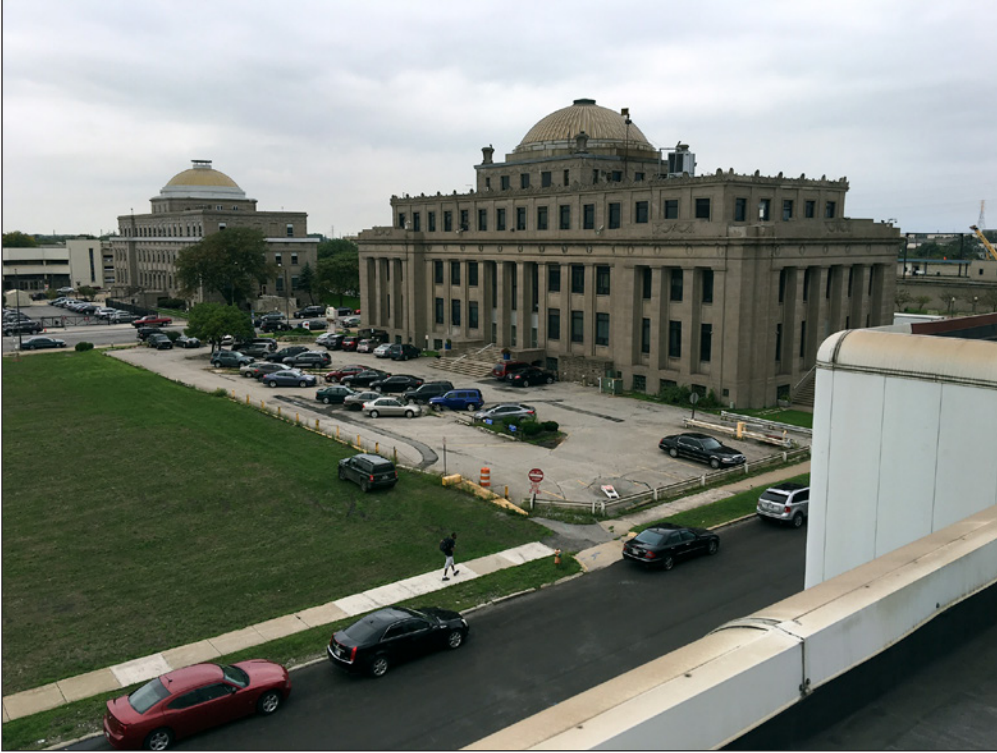
**Figure 2.** Gary City Hall in Gary, Indiana, before construction of green infrastructure (2016). Massachusetts Street in the foreground. Photograph by David C. Lampe, U.S. Geological Survey.

Gary City Hall was constructed in 1927. Before 2017, stormwater from the paved parking area on the south side of the building drained via an underground conduit and entered the city's combined storm and sanitary sewer beneath Massachusetts Street (fig. 2). The water was treated at the sanitary treatment plant, or, if the plant's capacity was overwhelmed by the volume of stormwater, it mixed with sewage and discharged to nearby tributaries of Lake Michigan.

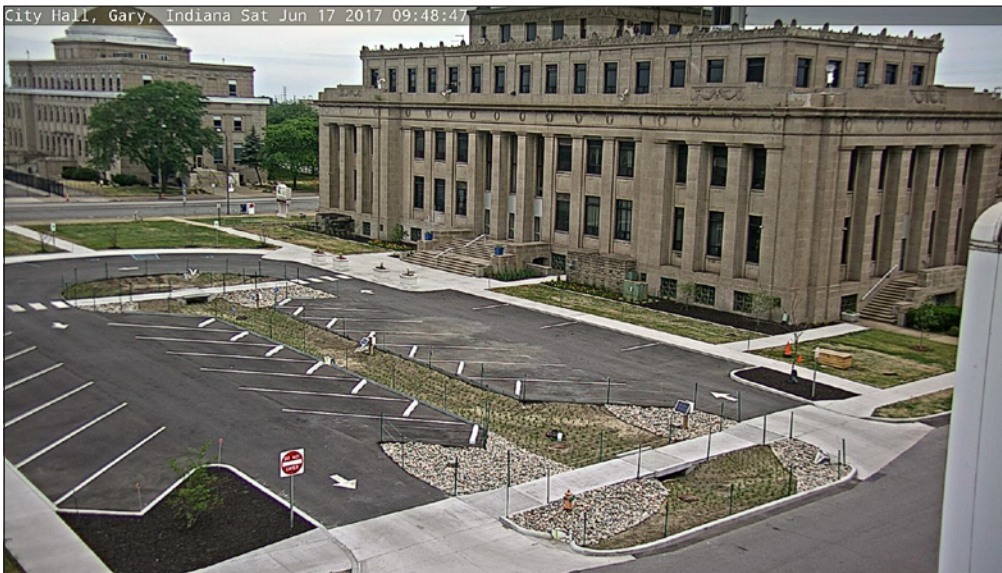
**Figure 3.** Gary City Hall in Gary, Indiana, after construction of the green infrastructure and rain garden (2017). Massachusetts Street in the foreground. Photograph by the U.S. Geological Survey.

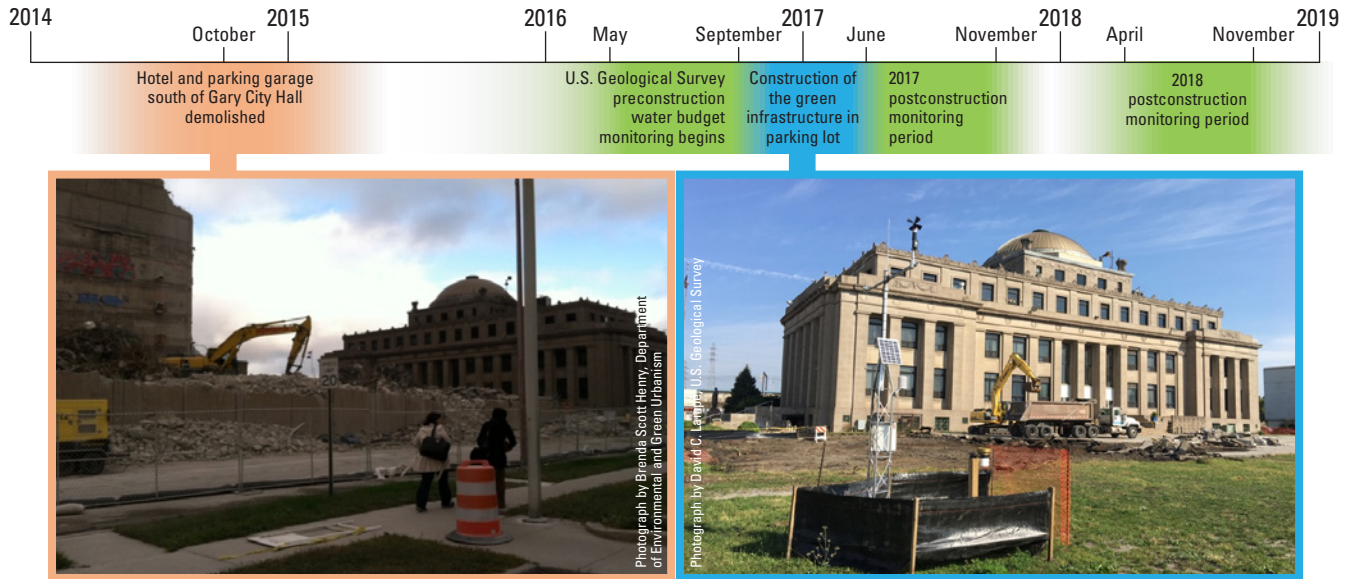
**Figure 5.** Timeline of construction and monitoring at the Gary City Hall study site, Gary, Indiana.

Land use modifications and additions of green infrastructure at the Gary City Hall study site were made from October 2014 through April 2017 (fig. 5). In October 2014, the hotel south of Gary City Hall was demolished, and the construction waste was removed. Much of the largely impervious paved area, as well as cement sidewalks that filled the area between the preexisting city hall parking area and the area to the south of the hotel, were replaced with turf. The parking area between the hotel and city hall building remained unchanged. Of the 49,500-ft<sup>2</sup> study area, approximately 31,800 ft<sup>2</sup> (approximately 64 percent) was covered with impervious materials (table 1). Three drains collected stormwater in the parking lot and discharged it to the storm sewer on the northeastern side of the study area (fig. 6A). The total drainage area for the parking lot drains was approximately 13,600 ft<sup>2</sup>. Stormwater was also collected and discharged to the storm sewer through a drain on Massachusetts Street on the east side of the study area from a drainage area of approximately 5,700 ft<sup>2</sup>. Other parts of the impervious area were estimated to drain to the surrounding grassed area or were areas where water ponded because of depressions in the asphalt and either evaporated or infiltrated through cracks.

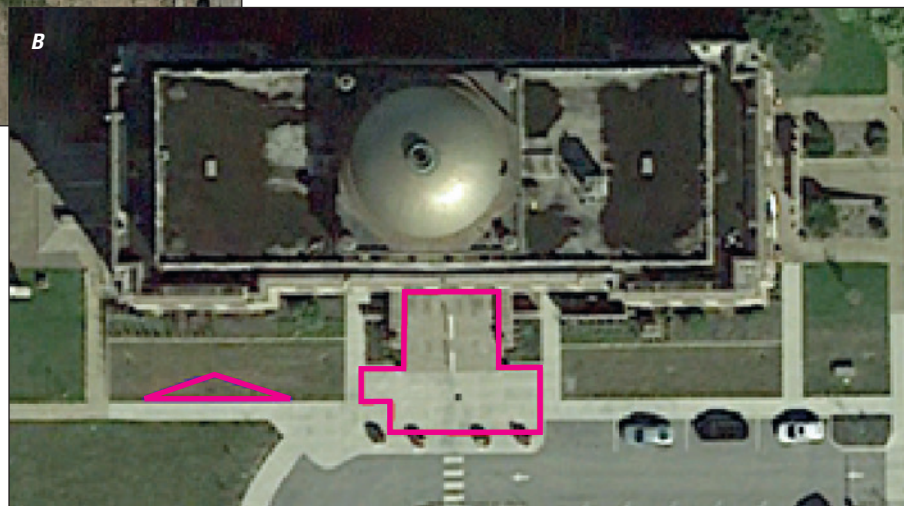
**Figure 6.** Images showing the *A*, preconstruction and *B*, postconstruction areas contributing runoff to the drain that runs directly in front of Gary City Hall and discharges to the main sewer beneath Massachusetts Street in Gary, Indiana. The areas contributing runoff are surrounded by colored polygons in each image.

In 2017, the preexisting parking area was replaced with a new parking area in front of city hall (fig. 6B). The new parking surface was gently inclined toward the center of the parking area to encourage flow of water toward the centrally located rain garden. The drainage area of the rain garden is approximately 24,500 ft<sup>2</sup> (table 1; fig. 7). Unlike the old parking surface, the new parking surface did not have cracks and imperfections that allowed water to enter the subsurface or sunken areas where puddles of water accumulated after rainfall and snowmelt. The new parking area covered approximately 29,600 ft<sup>2</sup> (60 percent) of the study area with impervious material. The drain in Massachusetts Street was removed and incorporated within the area of the rain garden during construction. The area surrounding the parking lot drains were changed during construction with the addition of more permeable materials around the drains. The drainage area of the parking lot drains after the construction was approximately 1,900 ft<sup>2</sup>.

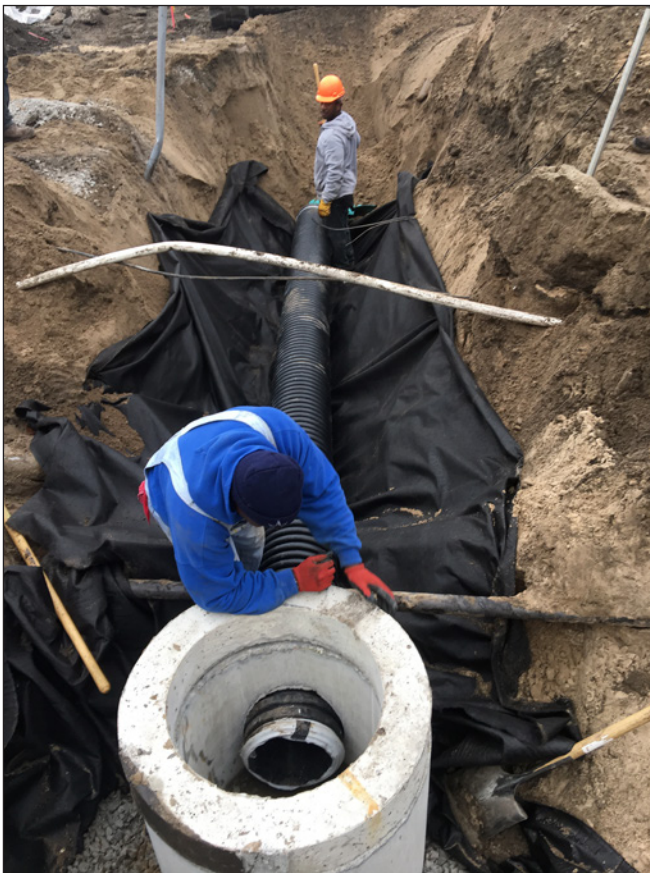
**Figure 9.** Photograph showing installation of perforated plastic pipe and concrete drop-down structure in the rain garden at Gary City Hall in Gary, Indiana. Photograph by David C. Lampe, U.S. Geological Survey.

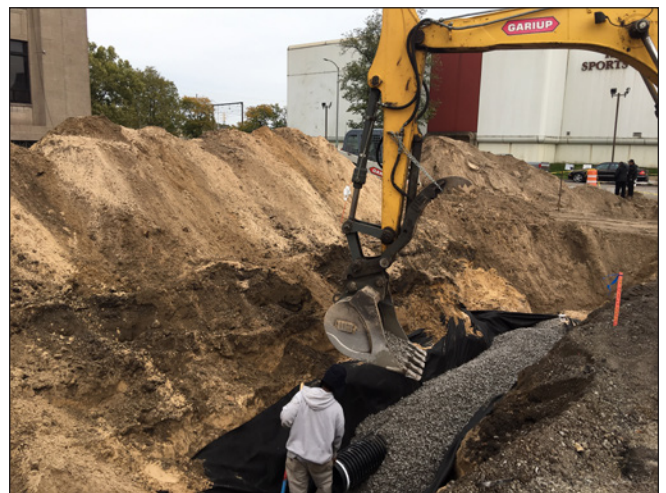
**Figure 10.** Photograph showing installation of gravel and root barrier around the perforated plastic pipe in the rain garden at Gary City Hall in Gary, Indiana. Photograph by David C. Lampe, U.S. Geological Survey.

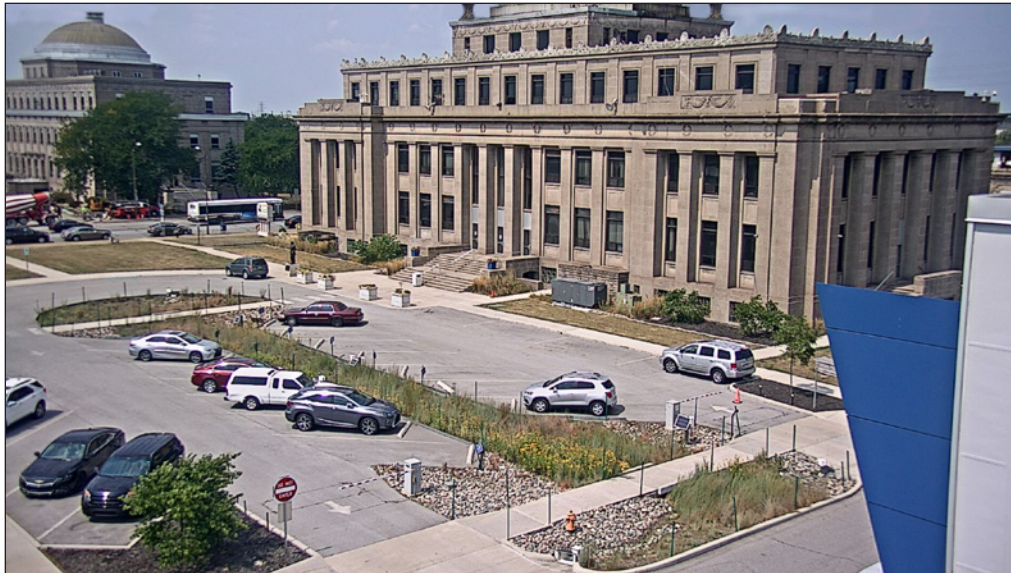
**Figure 11.** Photograph looking from east to west showing native plants growing in the rain garden at Gary City Hall in Gary, Indiana. Photograph by the U.S. Geological Survey.

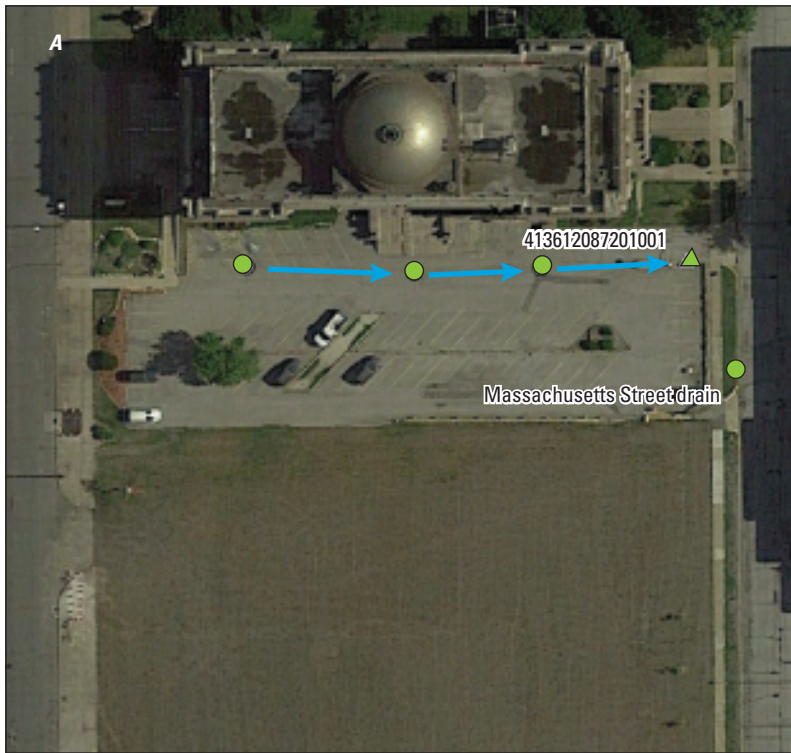
**Figure 14.** Photographs showing *A*, preconstruction and *B*, postconstruction parking lot drains connecting to the storm sewer at U.S. Geological Survey site city hall drain outflow at Gary, Indiana (413612087201001).

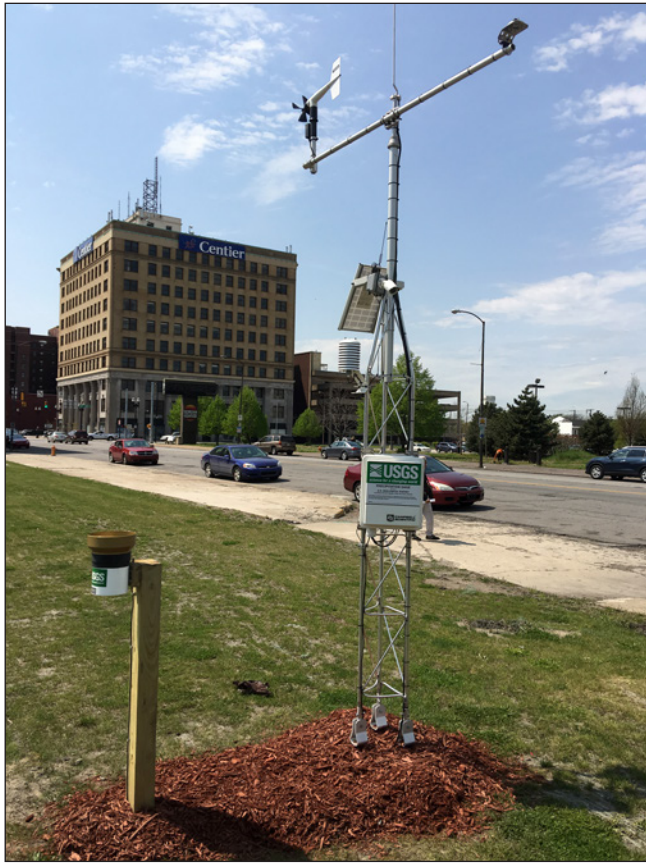
**Figure 15.** Rain gage and weather station at Gary City Hall study site in Gary, Indiana. Photograph by David C. Lampe, U.S. Geological Survey.

Precipitation data were continuously collected by using an unheated tipping-bucket rain gage colocated with the weather station about 175 ft southwest of Gary City Hall and 100 ft west of the rain garden (figs. 12 and 15; app. 1). The rain gage was mounted to a 5-ft tall post. The weather station and rain gage were serviced as per the USGS technical procedures available in USGS office of surface water technical memorandum No. 2006.01 (U.S. Geological Survey, 2006). The rain gage was not designed to measure snowfall, and data were removed from the record during periods when temperatures were below freezing.

The weather station installed for the study measured wind speed, wind direction, relative humidity, solar radiation, and air temperature (app. 1). Weather instruments were mounted to a single 10-ft-high tower near the western edge of the study area (fig. 15). The weather-station instruments were disassembled and cleaned, and calibrations for sensors measuring air temperature, humidity, wind speed and direction, and solar radiation were checked at least semiannually by comparing measurements with similar measurements made with sensors certified by the National Institute of Standards and Technology (<https://www.nist.gov>).

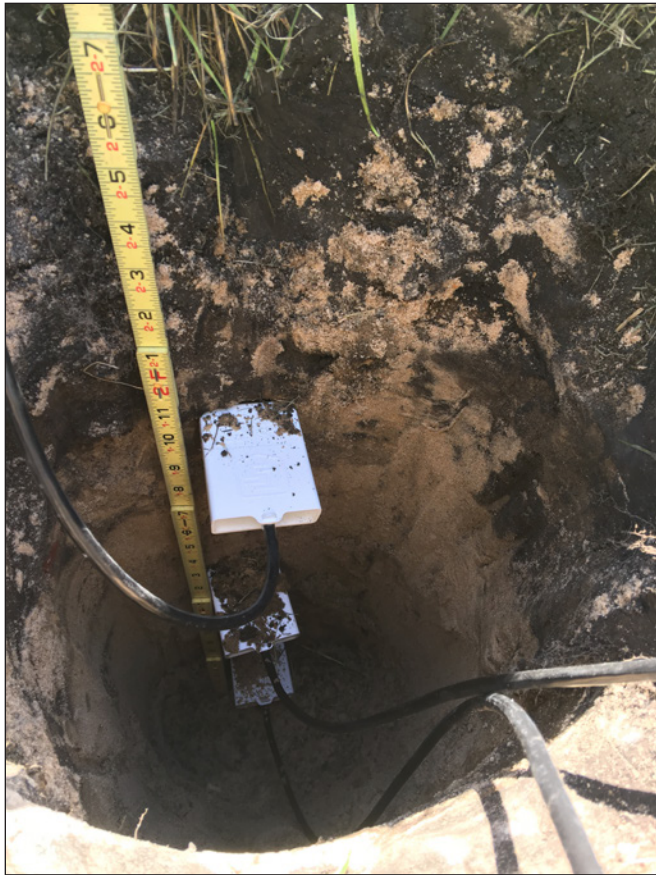
**Figure 17.** Soil-moisture sensors installed in the wall of an excavation at well CH–2 (413612087201301) at the Gary City Hall study site in Gary, Indiana. Photograph by David C. Lampe, U.S. Geological Survey.

Soil moisture was measured to document the redistribution of soil moisture in subsurface soils. Hourly soil-moisture measurements were made by using time-domain reflectometers (Campbell Scientific CS-655 Water Content Reflectometers) installed next to monitoring wells CH-1, CH-2, GWPK and BFPK at 10-, 20- and 30-in. depths and above and below the buried 12-in. perforated pipe in three places (fig. 17; app. 1). The probes have a range of 5–50 percent volumetric water content (cubic feet [ft<sup>3</sup>] moisture/ft<sup>3</sup> soil volume) and an accuracy of  $\pm 3$  percent. These ancillary data were collected to support observations about the hydrologic system at the study site (fig. 18).

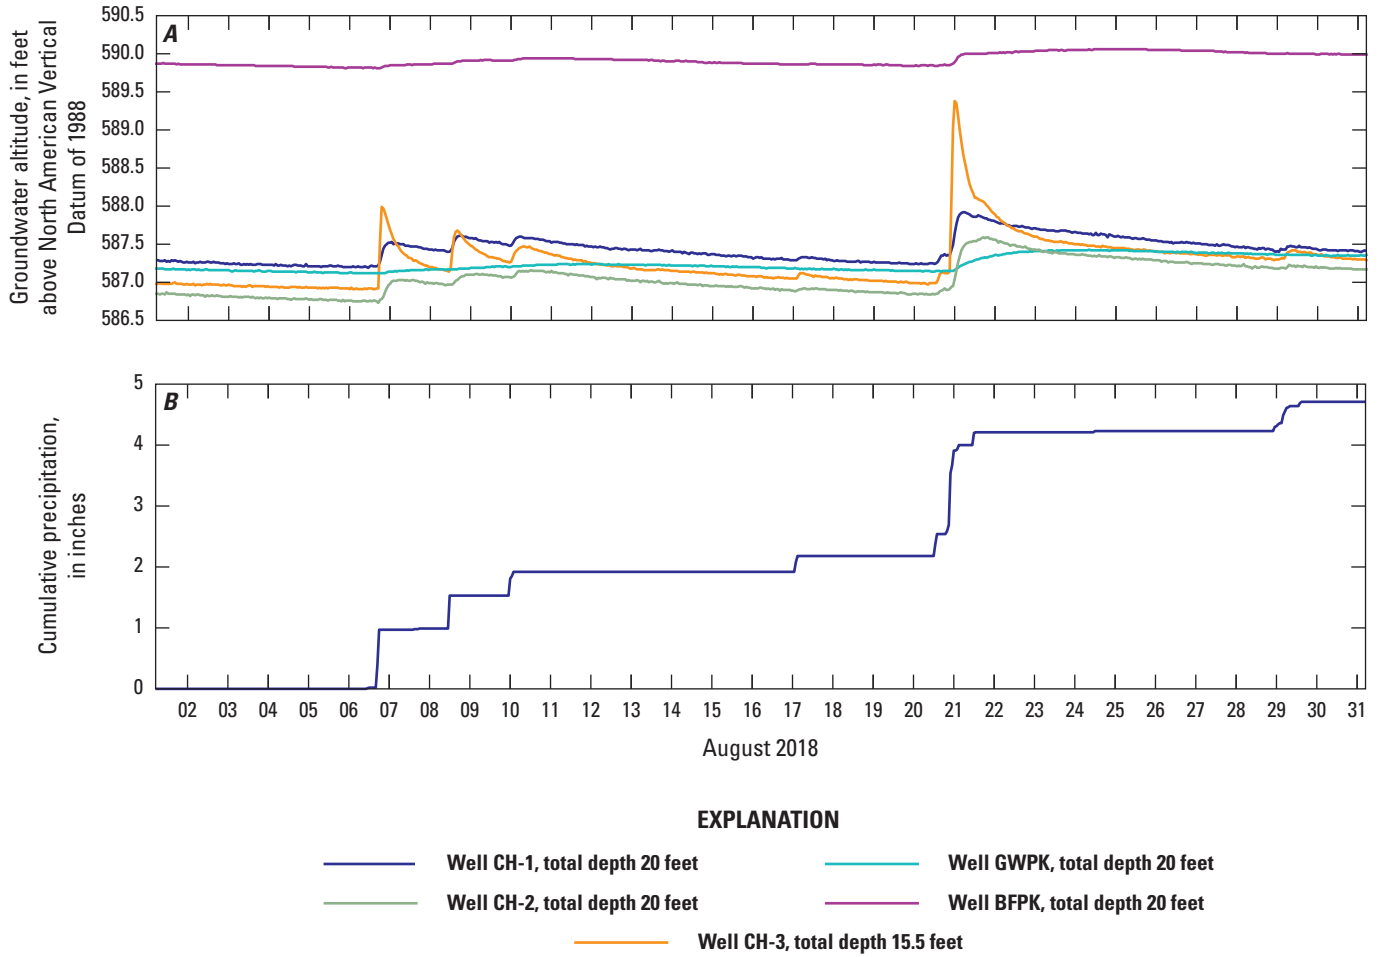
**Figure 19.** Example groundwater hydrographs for monitoring wells CH-1, CH-2, CH-3, GWPK, and BFPK for August 2018 showing the response of water levels to precipitation, Gary, Indiana.

The altitude (or level) of groundwater was continuously monitored in five wells (fig. 19). Two wells, CH–1 and CH–2, were installed in the green space south and west of Gary City Hall, respectively, in May 2016 (fig. 12; app. 1). Two background wells, Gateway Park (well name GWPK) and Buffington Park (well name BFPK), were installed in May 2016 140 ft north and 1,500 ft south of city hall, respectively. Well CH–3 was installed on the north side of the rain garden in April 2018 (fig. 12). Groundwater levels were measured at 1-minute intervals for CH–3 because of its depth and location in the rain garden and at 1-hour intervals in the other wells by using vented pressure transducers. Quality-assurance measurements of the depth to water were made with an electric tape approximately every 60 days.

recession (EMR) method (Heppner and Nimmo 2005; Nimmo and others, 2015). The EMR method is appropriate for hydrologic systems where groundwater levels indicate a rapid response to precipitation events (figs. 18 and 19). Rapid transmission of infiltration at Gary City Hall was indicated by sharp rises in groundwater levels that accompanied precipitation events (Follette and others, 2022).

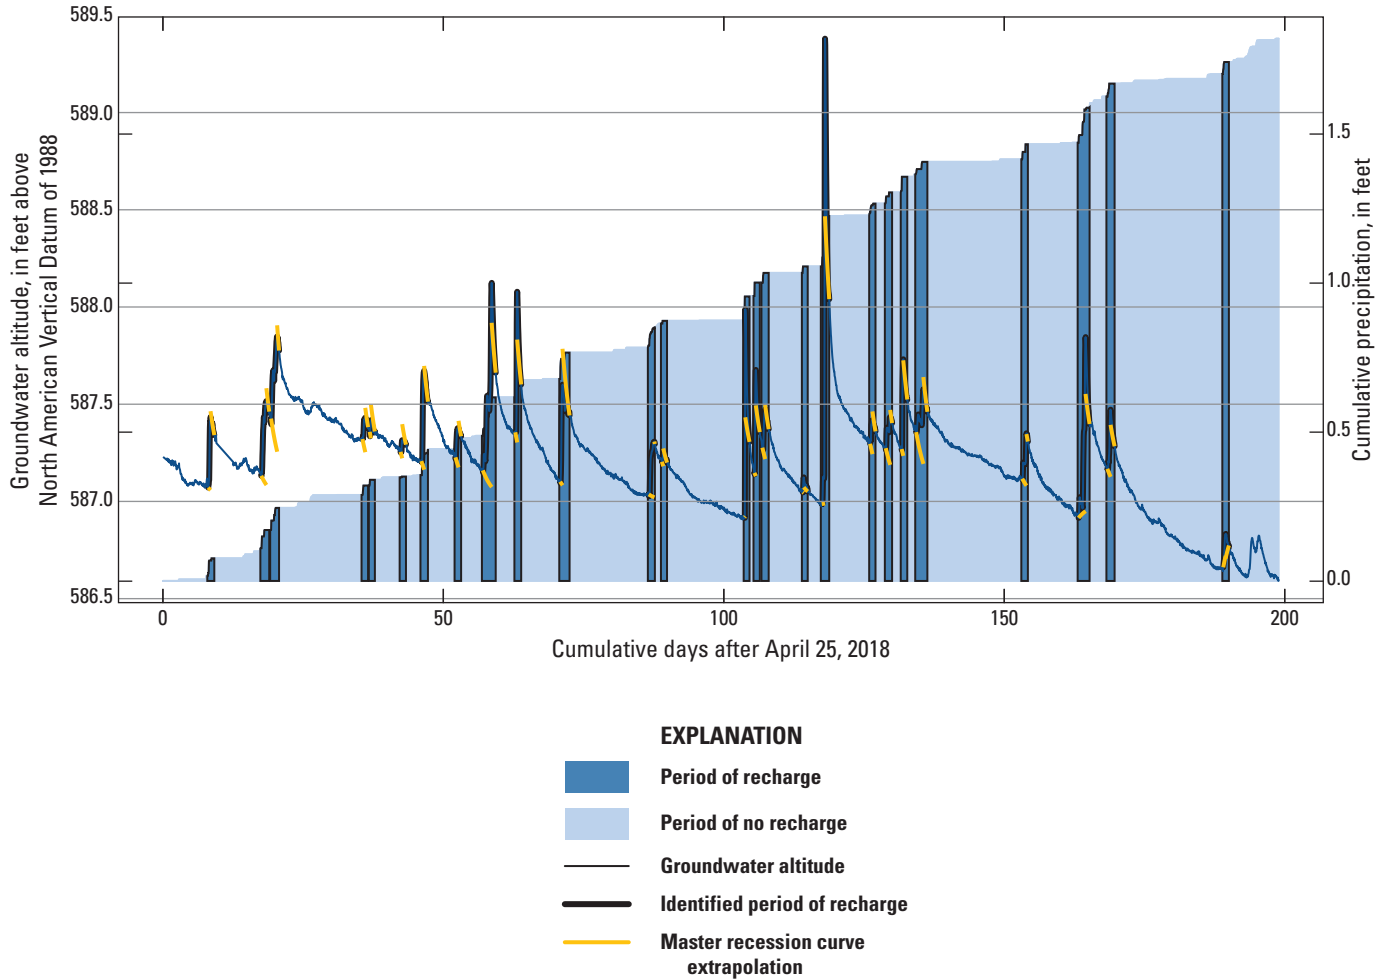
**Figure 20.** Example plot showing the continuous groundwater hydrograph, cumulative precipitation, and periods of episodic recharge identified by using the episodic master recession method for well CH-3 during the monitored period of 2018, Gary, Indiana.

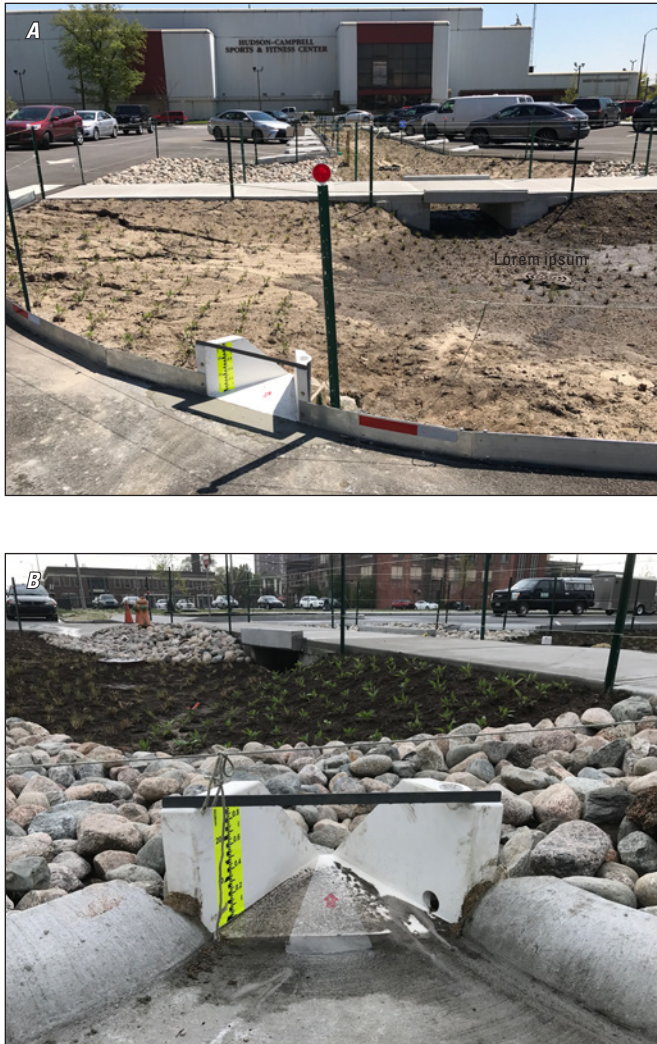
**Figure 21.** Photographs showing *A*, the metal border between the parking surface and rain garden and an H-flume used to measure runoff at Gary City Hall in Gary, Indiana, and *B*, the H-flume used during the study. Photographs by David C. Lampe, U.S. Geological Survey.

Runoff from the paved surfaces that entered the rain garden was measured by using 12-in. H-flumes (fig. 21). Five flumes were spaced around the perimeter of the rain garden. Flumes were instrumented with continuously recording pressure transducers, installed in prefabricated stilling wells, to measure the depth of water passing through the downstream V-shaped opening in the flume. The discharge of runoff was

calculated from the water depth by use of a manufacturer-supplied rating curve. Stilling wells were cleaned and transducers were checked for quality assurance approximately every 60 days. A 6-in. border of metal edging was installed around the parking lot to prevent runoff from flowing into the rain garden and instead directly through the inlets where the flumes were located.

Storage of water in the rain garden accounted for 56 and 59 percent of the water inputs in 2017 and 2018, respectively. Reservoirs for temporary storage could include the unsaturated zone beneath the rain garden and surrounding areas and the permeable pipe buried beneath the rain garden. Backwater conditions were observed at the eastern flumes leading to the rain garden from Massachusetts Street; these conditions would cause estimates of flow into the rain garden to be greater than actual flow, resulting in inflated estimated storage values (fig. 21B).

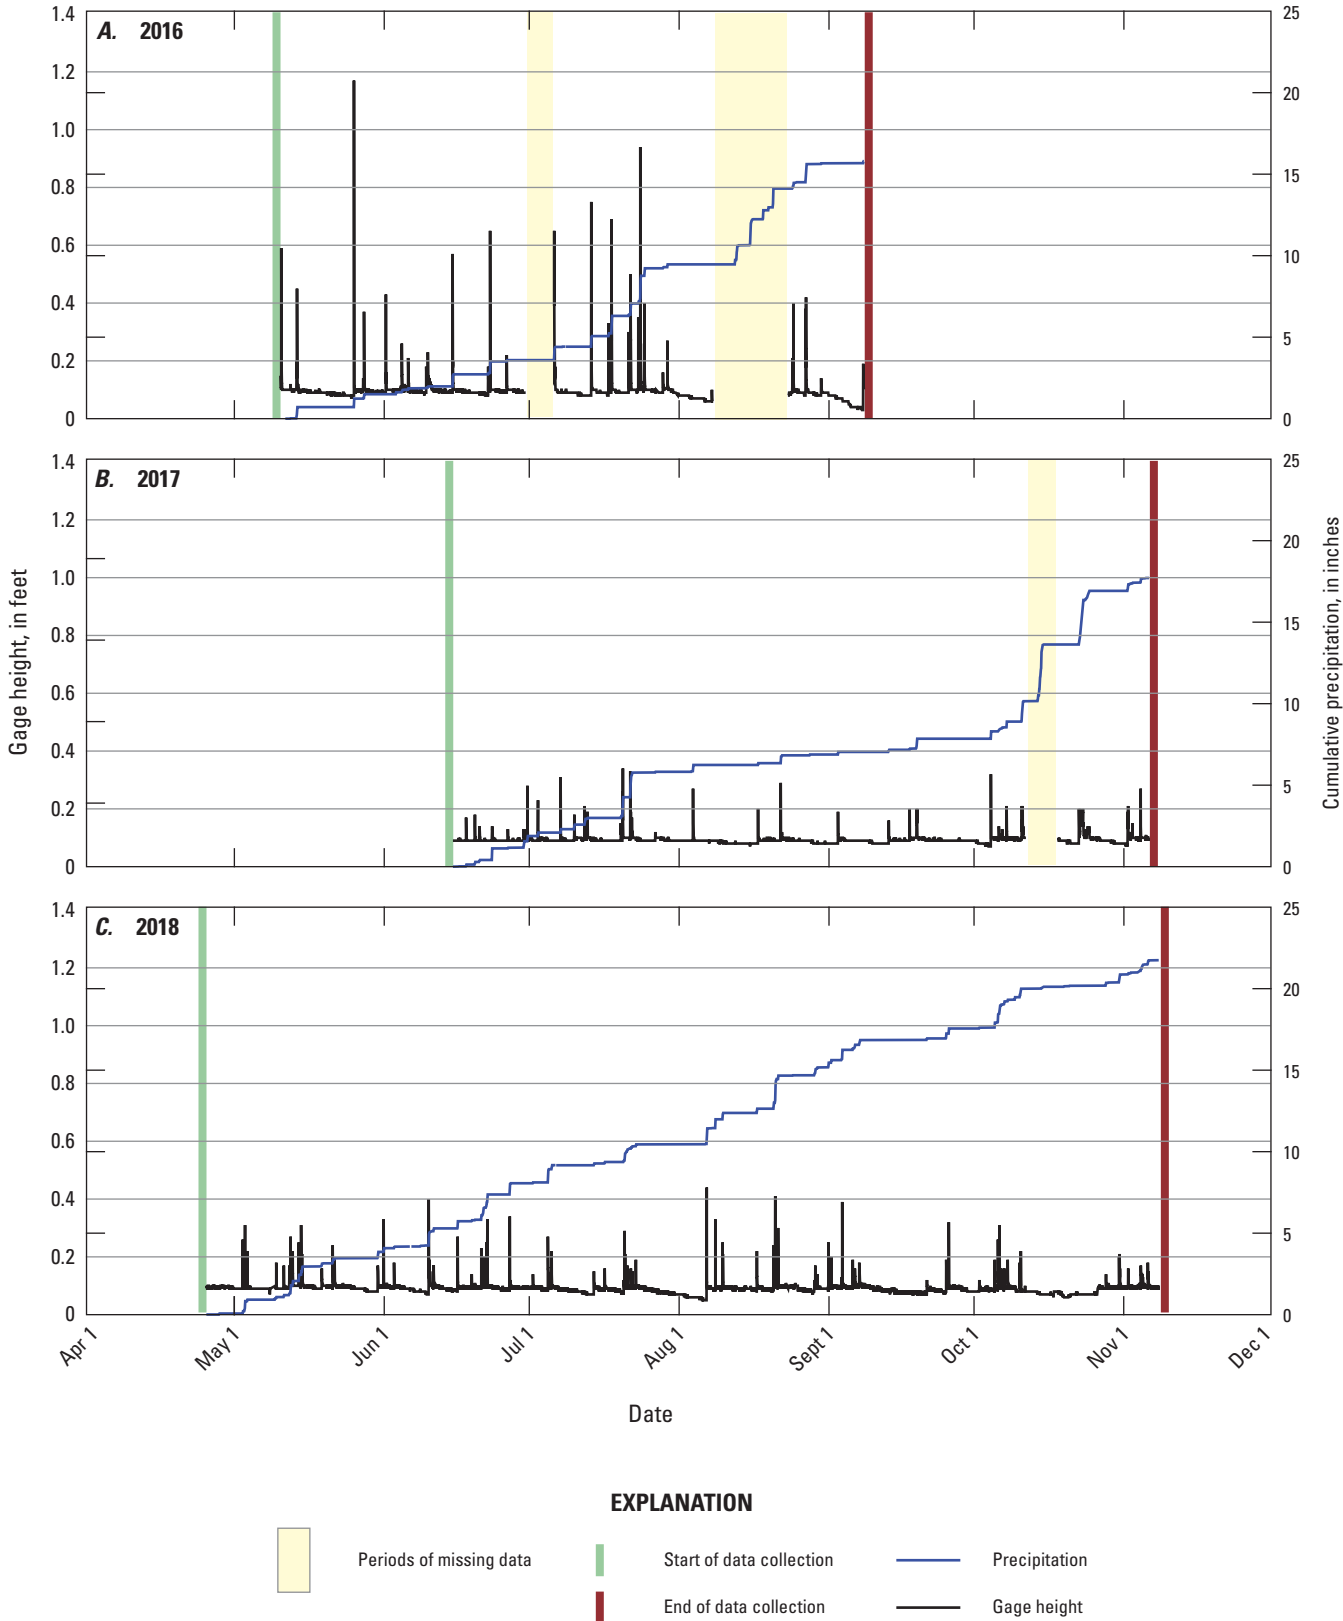
**Figure 22.** Plot of gage height in the drain with cumulative precipitation during the *A*, 2016 preconstruction, *B*, 2017, and *C*, 2018 postconstruction monitoring periods at Gary City Hall in Gary, Indiana.
